Importance of Properly Maintaining Handpieces and Quick Connect Couplers

JULY 28, 2020/IN ARTICLES/BY ASIDESIGN

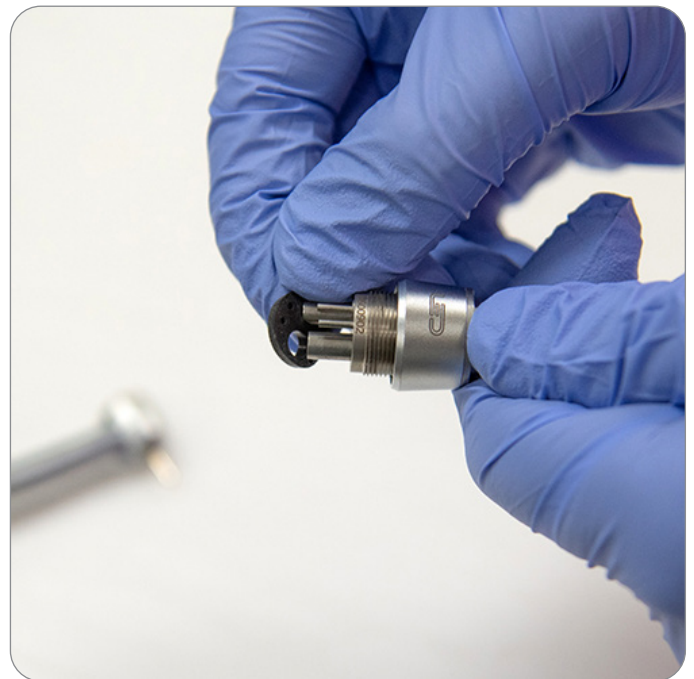
- The handpiece connection is not secure. The silicone gasket used on handpieces is a flange type gasket that requires the handpiece to be snugly tightened to the handpiece tubing. Most common handpieces use a quick connect coupler, so it is important to remove the hand-

piece and then verify the coupler is tight. Hint: To ensure a secure connection, tighten the coupler on securely and then loosen again. Clean the threads and then retighten.

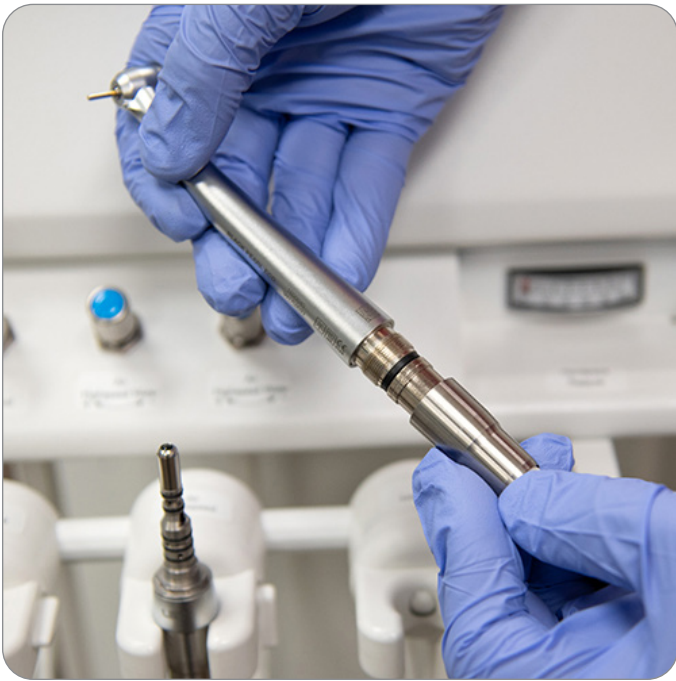
The second time will secure more than the first time, and the reason is related to the fine threads used on dental handpieces that can gall when tightening.

-The handpiece itself needs periodic service. The seals inside the handpiece head begin to wear and leak. Therefore requires more air pressure to operate or will run at less than efficient torque. Depending on the brand of the handpiece, you may need to replace or repair it based on the manufacturer's instruction.

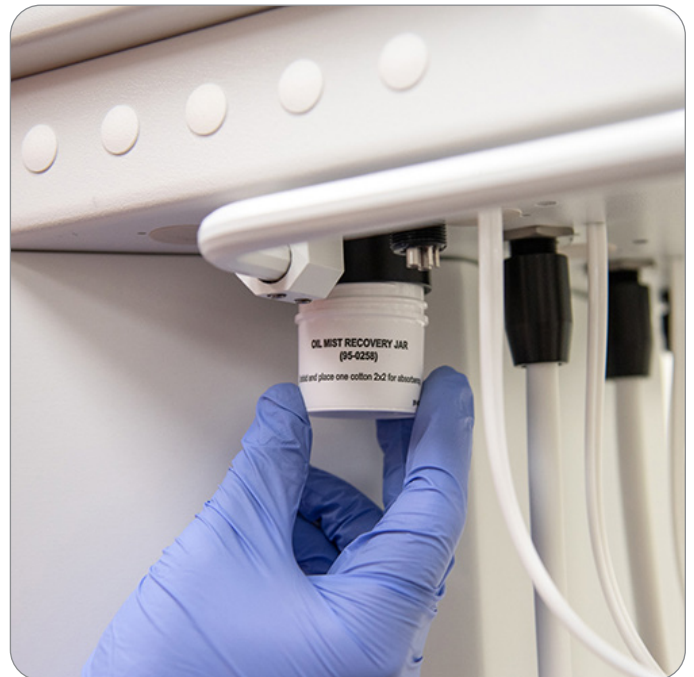
-Exhaust air not able to flow freely. If the exhaust air is restricted, the result will be a loss in torque even though the handpiece air gauge is reading normal. If that air is not able to exhaust at all, symptoms will include very low torque and the potential for the bur to stop completely. Verify the oil mist recovery jar on the dental unit is unobstructed and that the air can freely exhaust out it. Secondly, if you are using a quick connect coupler to attach the contra angle handpiece, the drive air or exhaust ports may be clogged with debris causing the handpiece to stall from a lack of airflow or exhaust.
